NCST Investigation of the Champlain Towers South Collapse

Cross-Project Panel Theme 2: Materials, Geotechnical, and Structural Analysis and Testing

CTS Investigation: Structural Code Checks

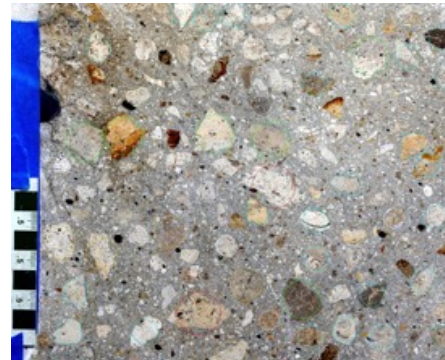
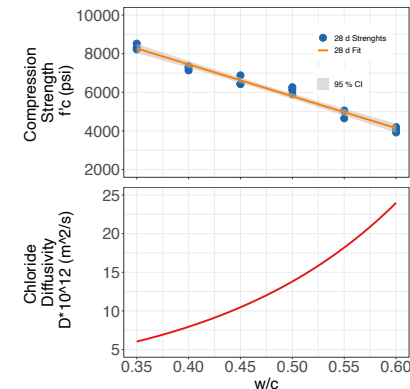
Determine aggregate proportions and size:

- Air voids, mortar, and aggregate fractions determined by “Point Count.”
- Aggregate size determined by statistics-based visual comparison.

Observations used to determine mixture proportions for trial mixes:

- Coarse aggregate and water fraction held constant for workability.
- Water-to-cement ratio (w/c) varied to control strength.
- Results show that ~ 4000 psi can be achieved at high w/c .
- Implications for structure service life and durability.

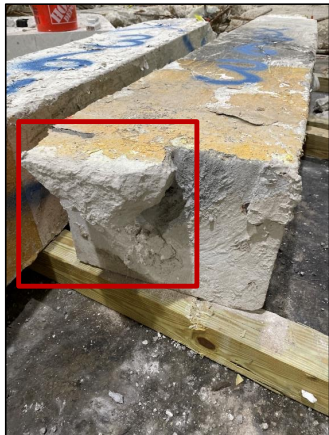
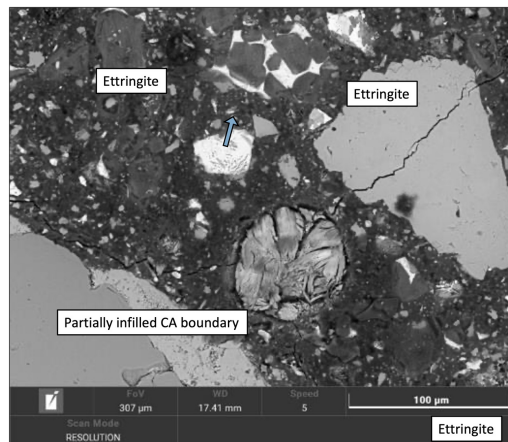
Preliminary Petrography: We have observed evidence of:

- Microstructural changes due to environmental factors
- Higher air content and water/cement ratio in slab concrete relative to column concrete
- Lower air content and water/cement ratio in column concrete

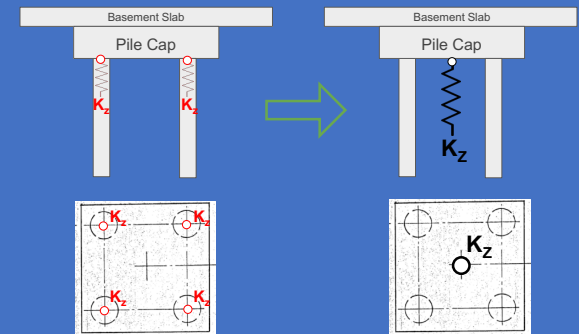
Foundation Compliance – Pile Stiffness – Equivalent Spring Simplified/Preliminary Evaluations

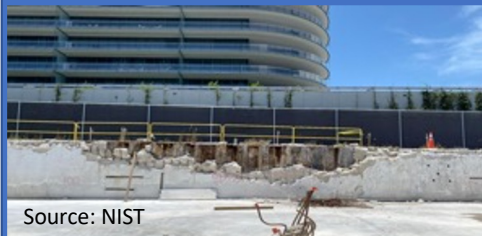
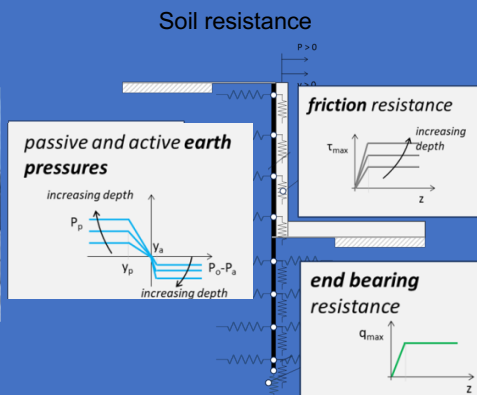
South Wall Lateral Behavior Analyses

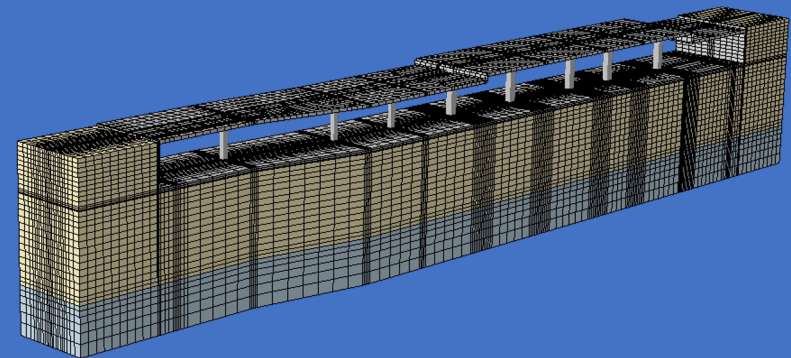
Advanced Three-Dimensional Finite Element Soil-Structure Interaction Models
